Intel[®] Mobile Celeron[™] Processor Specification Update

Release Date: January 2000

Order Number: 244444-011

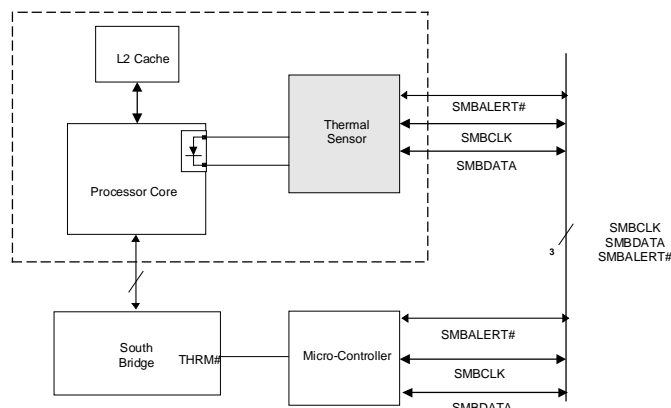
Figure 1. An Example of Microcontroller Driven Thermal Management

H29. Thermal Sensor May Assert SMBALERT# Incorrectly

Problem: The Intel Celeron Processor Mobile Module has a thermal sensor that monitors the processor core's temperature. Please note that desktop systems could have a similar thermal device. The thermal sensor asserts SMBALERT# if the processor temperature exceeds the temperature limits set in the Alarm Threshold Registers (T_{HIGH} , T_{LOW}). It also sets the corresponding Status Register bits to identify the cause of the interrupt. Figure 1 gives one example of the how the SMBALERT# signal could be used in a system.

Implication: There is no system impact from this erratum if temperature polling is used for processor thermal management. If the SMBALERT# interrupt is employed to manage processor thermal sensing, then servicing the false interrupt may result in premature system action depending on the software and hardware implementations used. The rate of the false interrupts is less than the auto-convert rate of the thermal sensor.

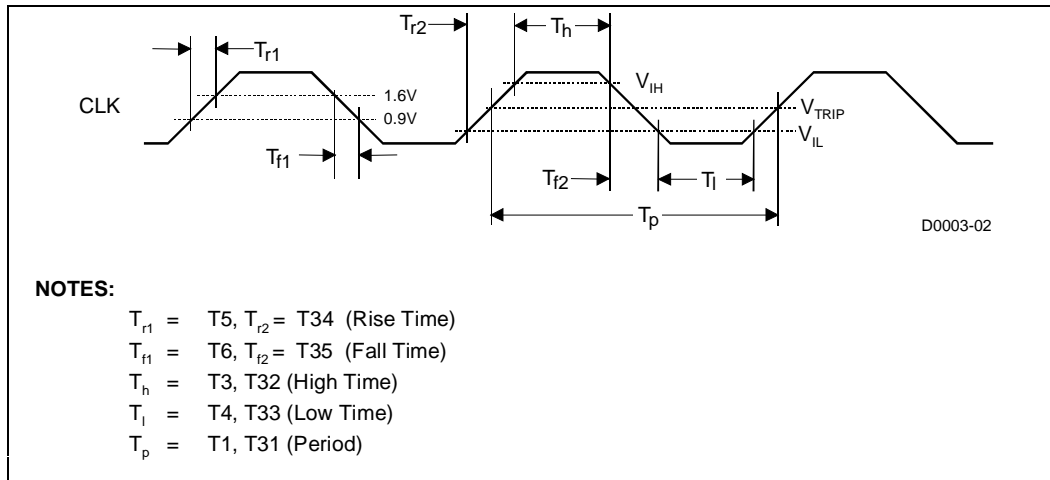
Figure 3.3 Generic Clock Waveform

H11. Generic Clock Waveform Figure

Figure 3.3 in the *Intel® Mobile Celeron™ Processor in μ PGA1 and BGA1 Packages at 366 MHz, 333 MHz, 300 MHz, and 266 MHz* datasheet (Order Number 245112-003) has been updated. The following figure is to replace the one in the above document.
